FOURTH FIVE-YEAR REVIEW REPORT OPERABLE UNITS 2 AND 4 SCHOFIELD BARRACKS HONOLULU COUNTY, HAWAII

AEDB-R Nos. SCHBR-19 and SCHBR-12

September 2017

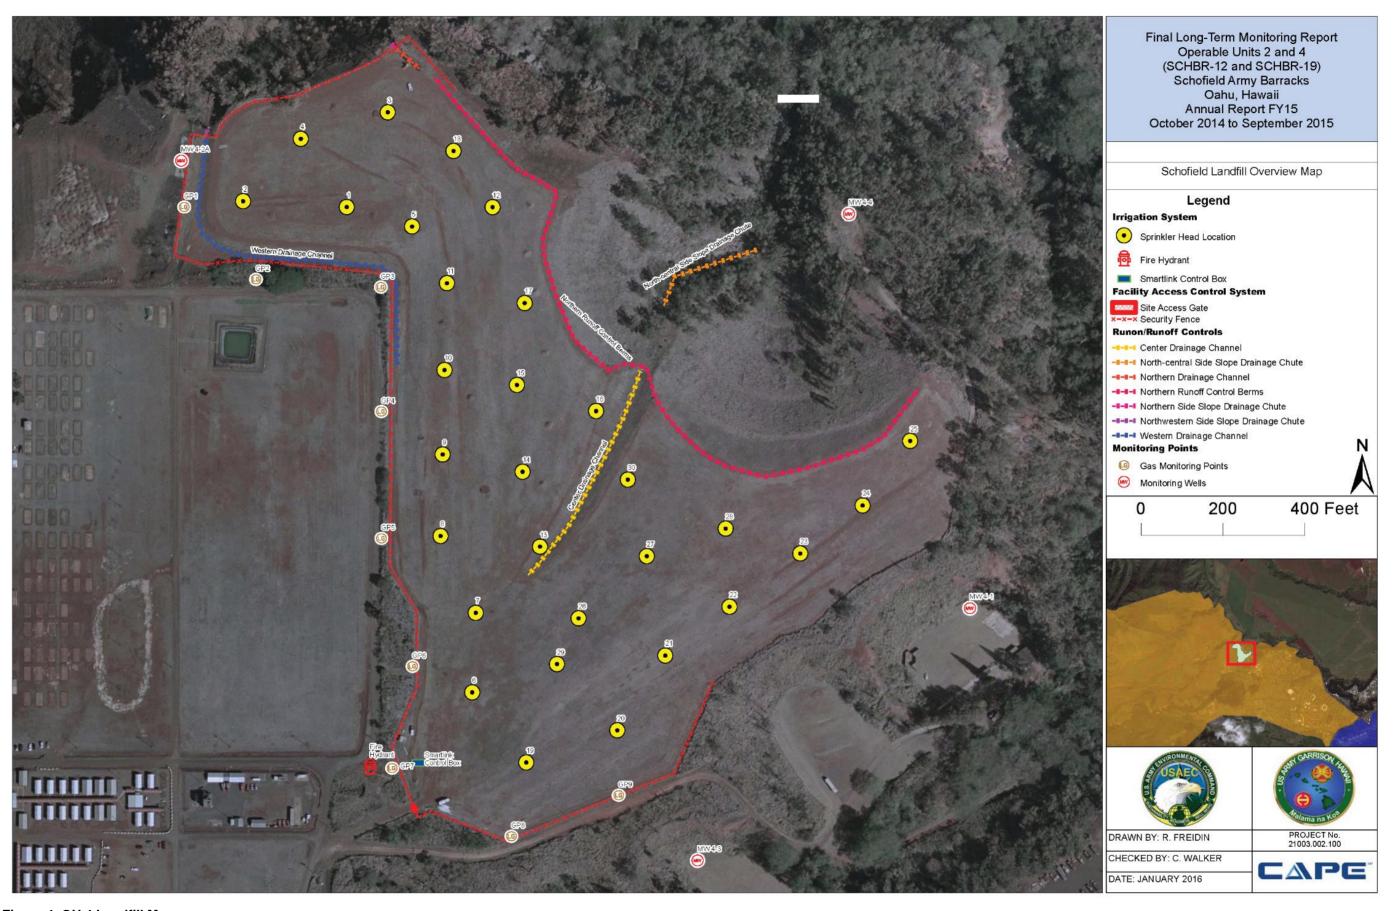
Figure 4. OU 4 Landfill Map Figure source: AEC and DPW, 2016

- Clearing and grubbing of existing vegetation and selected trees and shrubbery
- Repairing landfill cracks
- Filling of landfill subsidence areas
- Regrading the surface of the landfill cover to maintain a positive slope to promote surface water runoff
- Landscaping with new vegetation
- Repairing a portion of the existing central drainage system
- Repairing eroded areas on the sides of the existing central drainage system
- Installing a cement rubble masonry channel
- Installing nine new gas monitoring wells and modifying five existing monitoring wells

Upon completion of remedial activities, EPA determined that the landfill cap, drainage, and monitoring systems were complete, functional, and operational. The main features of the landfill cap are shown on Figure 4.

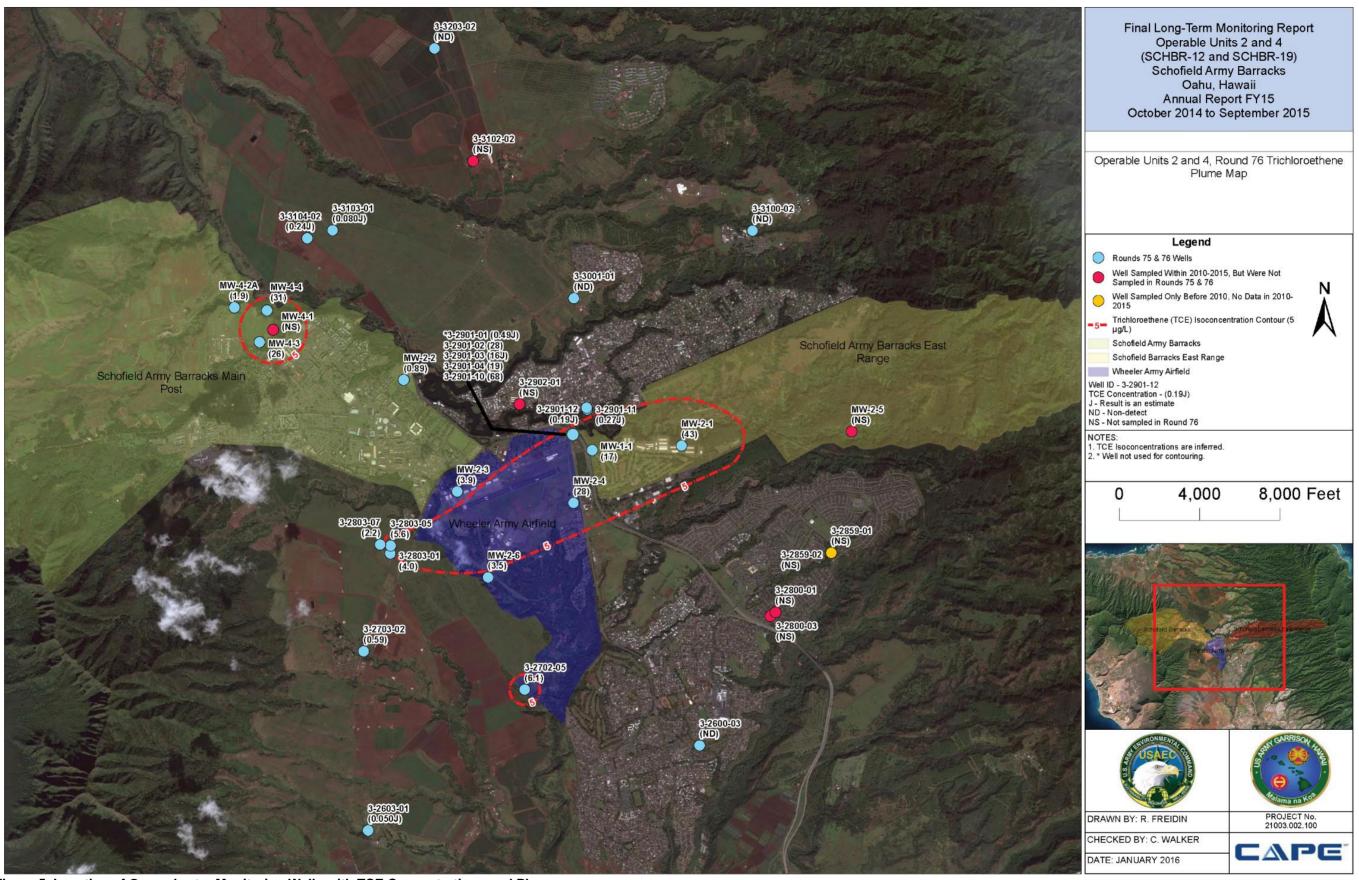
Figure 5. Location of Groundwater Monitoring Wells with TCE Concentrations and Plumes

Table 4 summarizes the groundwater sampling results for TCE and carbon tetrachloride between October 2010 and October 2015. Figure 5 shows the locations of the monitored wells, concentration of TCE measured between 2014 and 2015, and plume map of the TCE. Figure 5 labels the wells with either the state well ID or the well name used for monitoring. Table 4 lists both the state well ID and the well name. Carbon tetrachloride was detected in 23 out of the 33 wells sampled at concentrations between 0.04 and 4.2 μ g/L, which are below the MCL of 5 μ g/L. The highest concentrations were detected near the landfill (OU 4). TCE was detected in 26 out 33 wells at concentrations between 0.05 and 70 μ g/L, with 13 of them exceeding the MCL of 5 μ g/L. Well 3-2603-01 (Hawaii Country Club), had a detection of 0.05 μ g/L of TCE in October 2015 which is below the limit of quantitation and above the method detection limit so the value is an estimate. The highest concentrations of TCE were detected at the Schofield supply wells and the landfill.
